## Pipe Re-lining CASE STUDY

# Fresno Irrigation District (FID) Little Houghton Rehabilitation Project 2024

Central Valley, California

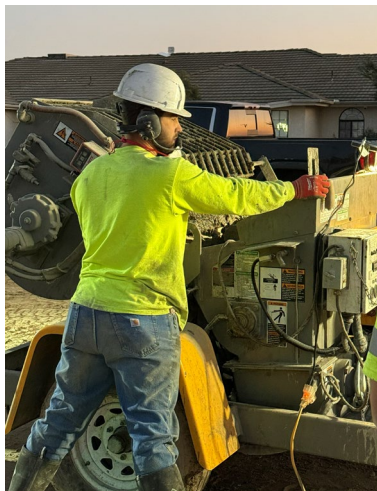
Proprietary Shotlining Mix

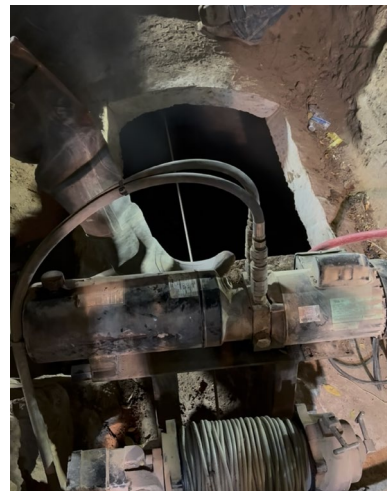
Proprietary Shotlining Equipment
