## Pipe Rehabilitation CASE STUDY

# South San Joaquin Irrigation District (SSJID)- District Wide Pipeline Rehabilitation Program

Central Valley, California

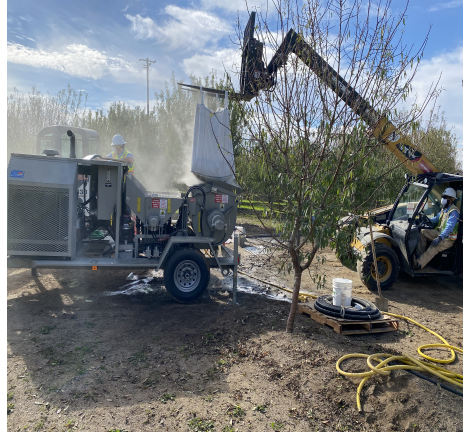
Proprietary shotlining mix

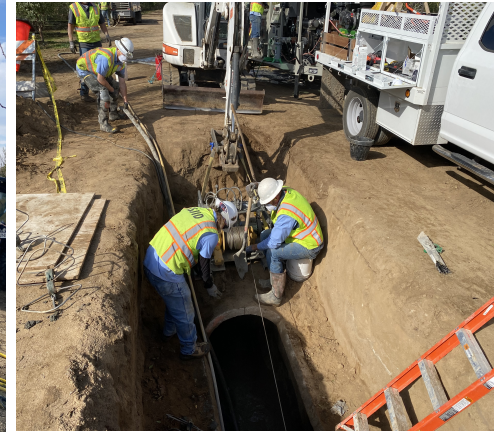
Proprietary Shotlining equipment

- Utilized a **shotlining** mixer /pump combo for 1,000-pound bags of proprietary shotlining culvert mix.
- Applied the mixture through 300 feet of 1.50" diameter concrete hose to nozzle attached to Centrifugal Pipelining Machine (CPM) on a sled.
- The nozzle attached to the CPM, spinning at rapid speed, sprayed the material at 5000 psi onto pipe walls at a consistent ½" to ¾" thickness, covering holes and cracks – essentially forming a new pipe within the old pipe.
- Controlled application thickness (½" to ¾") by adjusting winch speed based on pipe size.
